# Manhole Inspection Summary

Manhole # S51O\_\_067MH

Insp Date: **9/15/09 10:00 AM**

**Location** Address: **1111 S.Linwood St.**

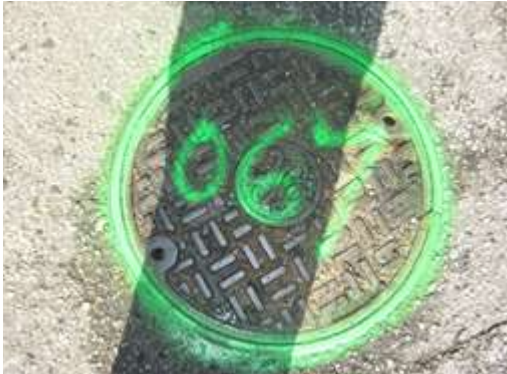
Miscellaneous

MH Lid

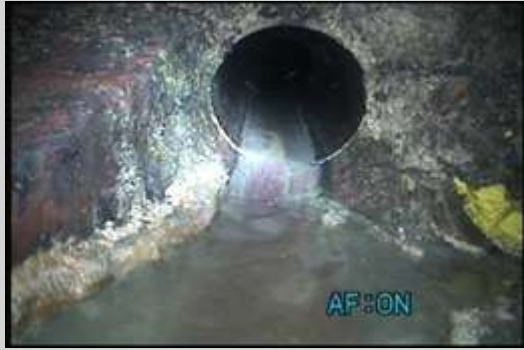
6 O'Clock Inflow

8 in. Circular Gravity Sewer

Pipe In @ 6 O'Clock

Pipe Height: **8.4** (in.) Rod and Bar (Angled)

Pipe Material: **Clay** ☐ Pipe Lined

Infiltration: **None** Pipe Seal Cond: **Sound**
